Manhole Inspection Summary

Manhole # S19CC1014MH

Insp Date: **3/12/07 12:56 PM**

Location Address: **3632 PARKDALE AVE**

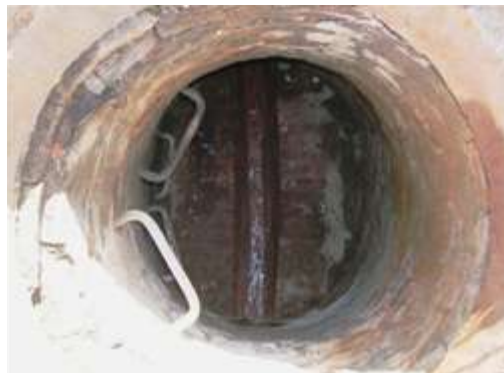
Top View

Bench debris.

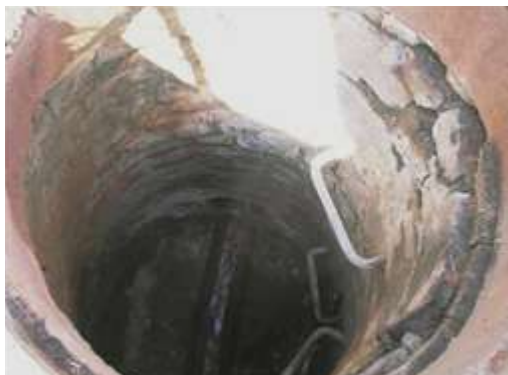
Defect

Adjustment cracks, loose brick, deterioration and infiltration. Corbel and Barrel infiltration - other side.

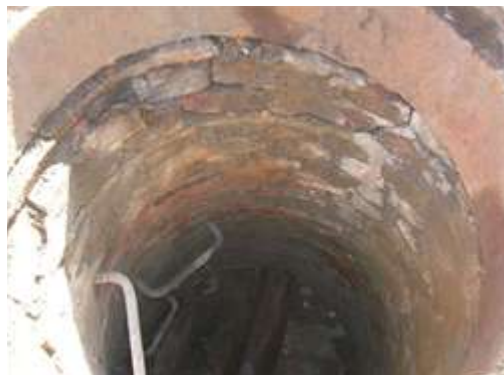
Defect

Adjustment cracks, loose brick, deterioration and infiltration. Corbel and Barrel infiltration.

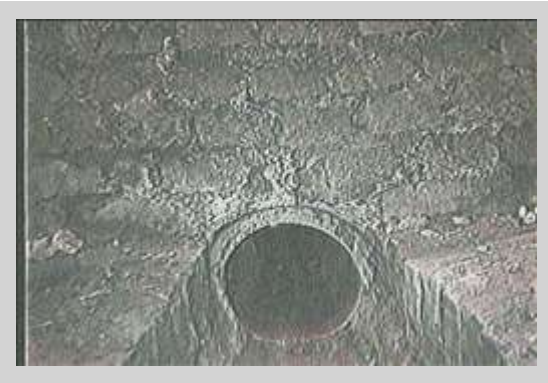
8 in. Circular Gravity Sewer Pipe Out @ 12 O'Clock

Barrel deterioration and infiltration.

Infiltration: **Evidence** Pipe Seal Cond: **Unknown**

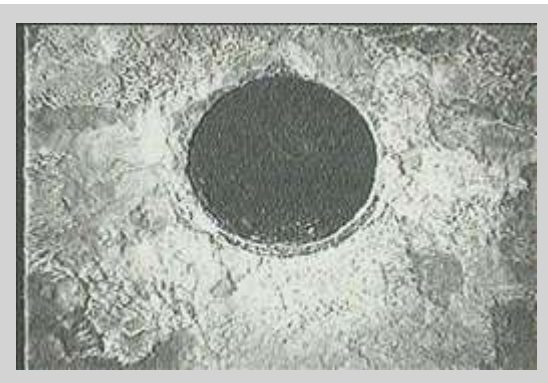
8 in. Circular Gravity Sewer Pipe In @ 6 O'Clock

Infiltration: **Evidence** Pipe Seal Cond: **Roots**

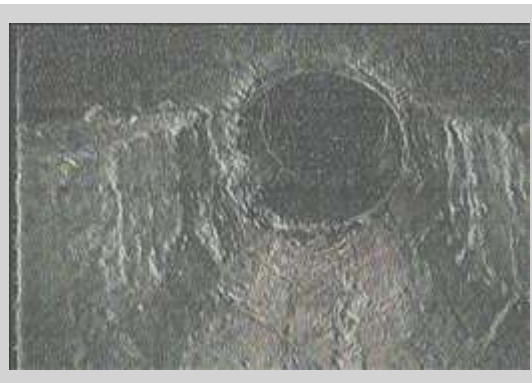
Drop In @ 6 O'Clock

Channel deterioration.
